## Introduction

## Details of Samples

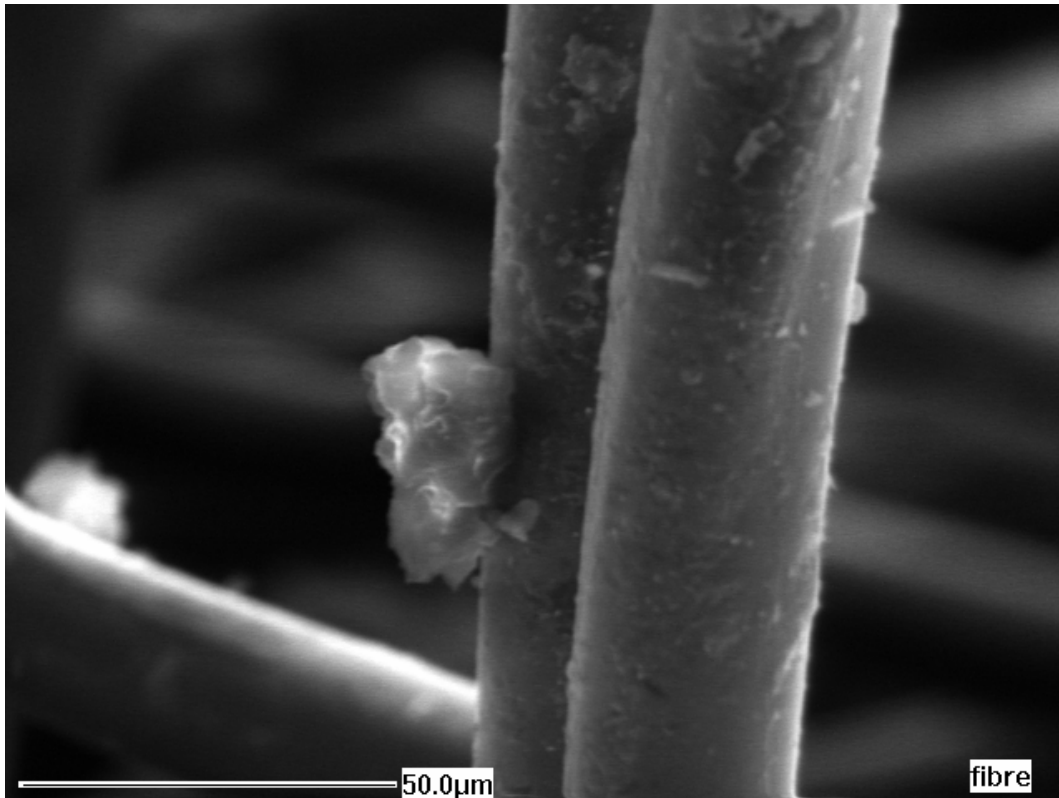
A significant number of fibres were observed to have surface deposits, however, there was no apparent alteration to the fibre material at or adjacent to these fibres suggesting they had not contributed to the failure.

Plate 5  
Showing a deposit on the surface of one fibre

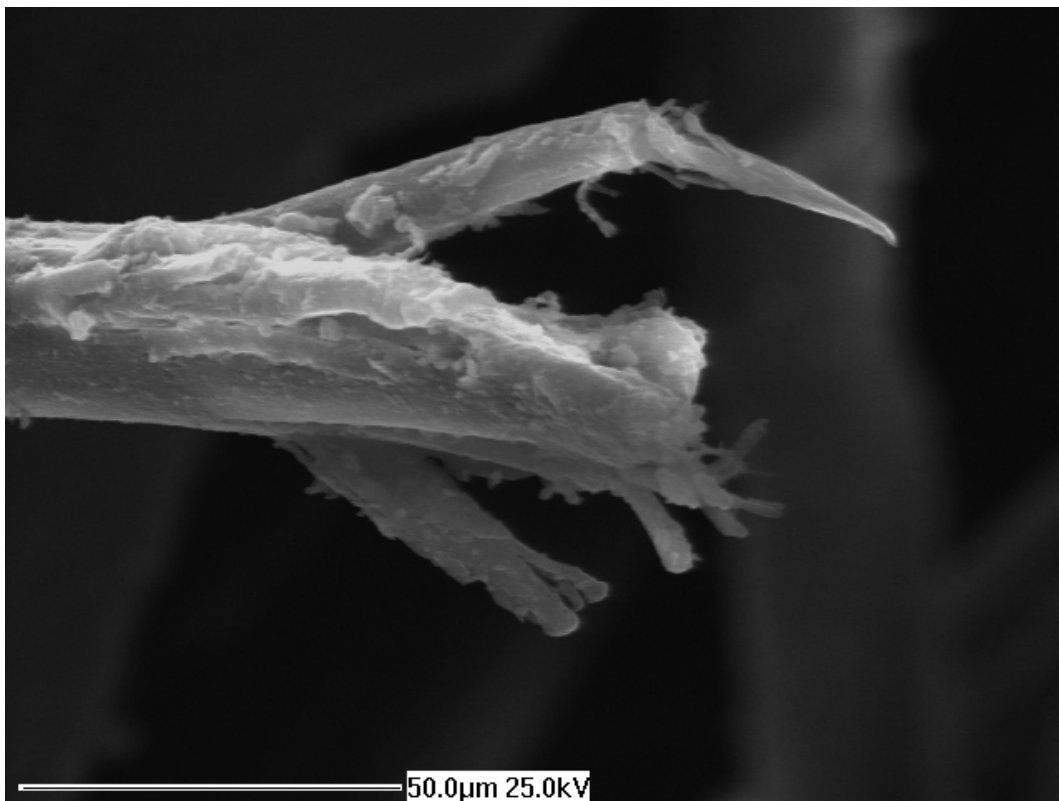
The analysis indicated that the fractured ends of the fibres had been degraded which had resulted in cracking of the fibre material, with some of these cracks extending as much as 90 microns from the fracture.

The analysis also showed that the average fibre diameter was 31 microns and some of the affected fibres had a diameter of approximately 42 microns adjacent to the failed top.

Plate 6  
Illustrates the degradation of the fibre material close to the failed end
