Offshore Wind Turbine
Maintenance Specialist

Monopile

Case Study

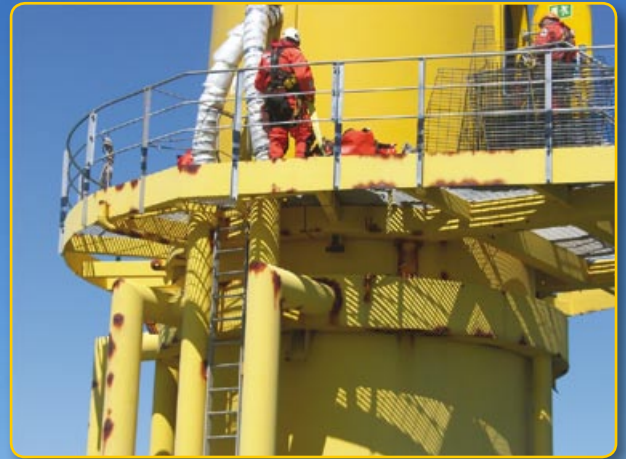
Removal of gratings and davit arms in preparation for grit blasting.

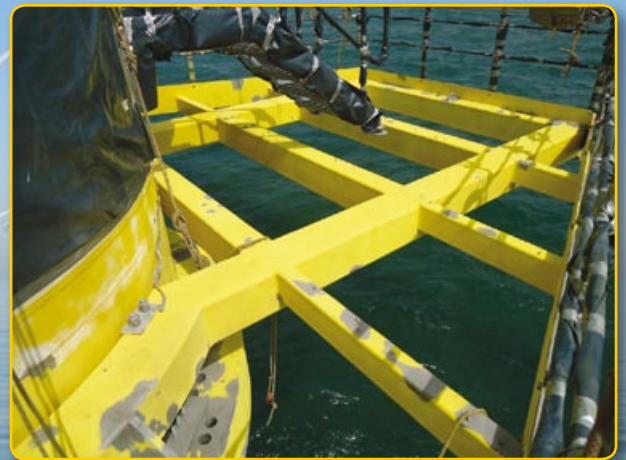
All corrosion removed to blast standard SA 2.5 and sound paint profiled to take new coating

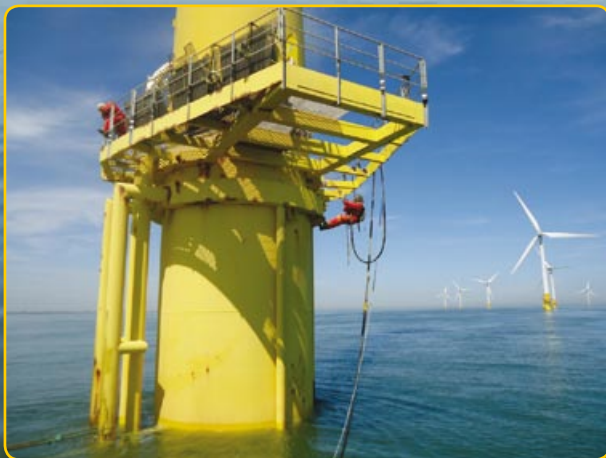
Grit blasting performed using highly skilled roped access techniques

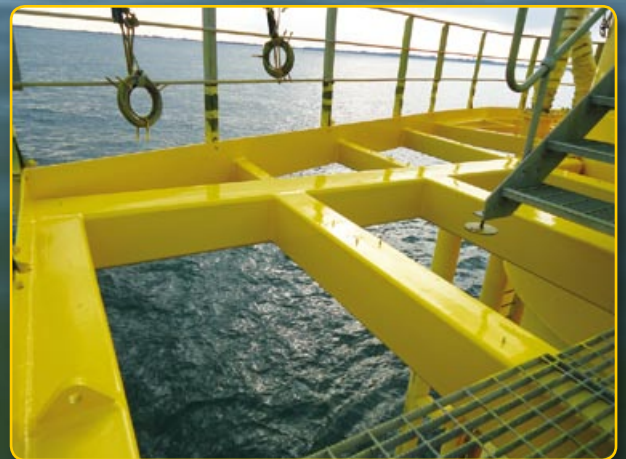
New protective coating, airless sprayed applied to the required thickness.

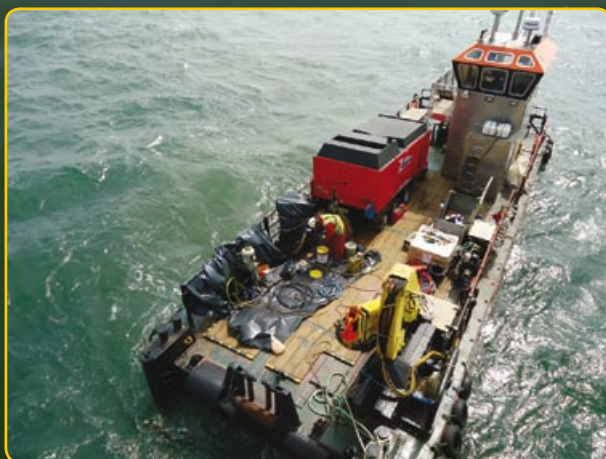
Workboat alongside monopile carrying all necessary tools and equipment to perform blasting, coating and mechanical works.

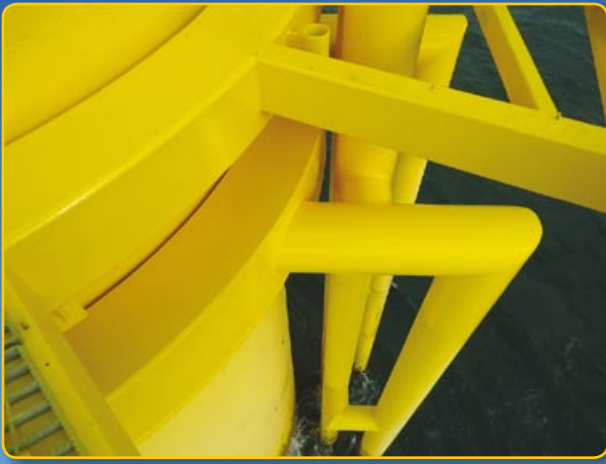
New protective coating applied to underside of walkway.

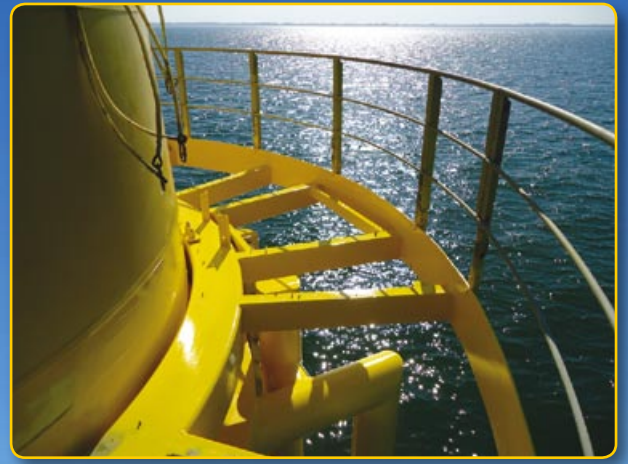
New protective coating applied to top sides of walkway.

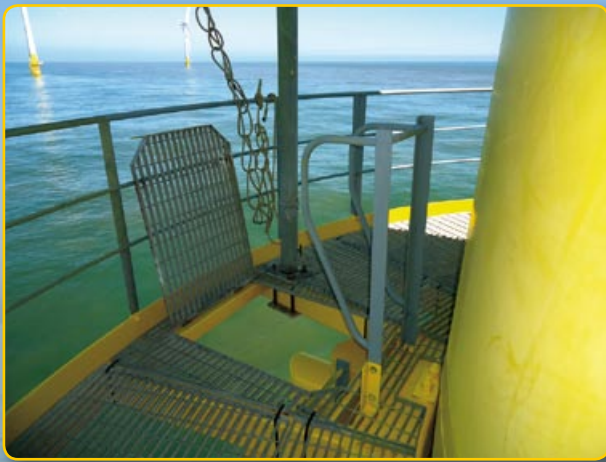
Re-install grating and davit arms.

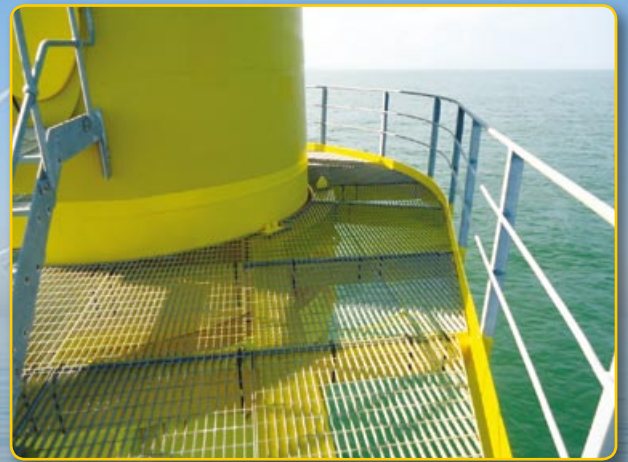
Re-install grating.

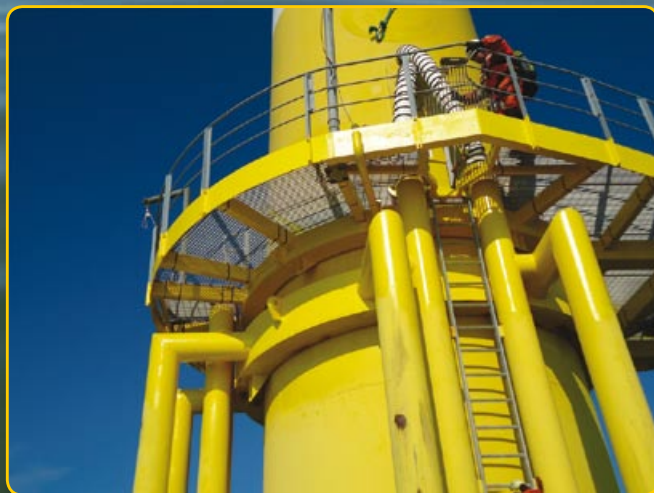
Phase 1 refurbishment to walkway and underside of monopile complete. Phase 2 will take monopile refurbishment from underneath top collar section below grating down to sea level.
